AF91.12-P-6003A	Easy-entry seat will not operate	21.3.02

MODEL 163.154 /172 #A as of 145273,
163.136 /154 /172 #X as of 708319,
163.113 /128 /175 with CODE (847) 3rd seat row

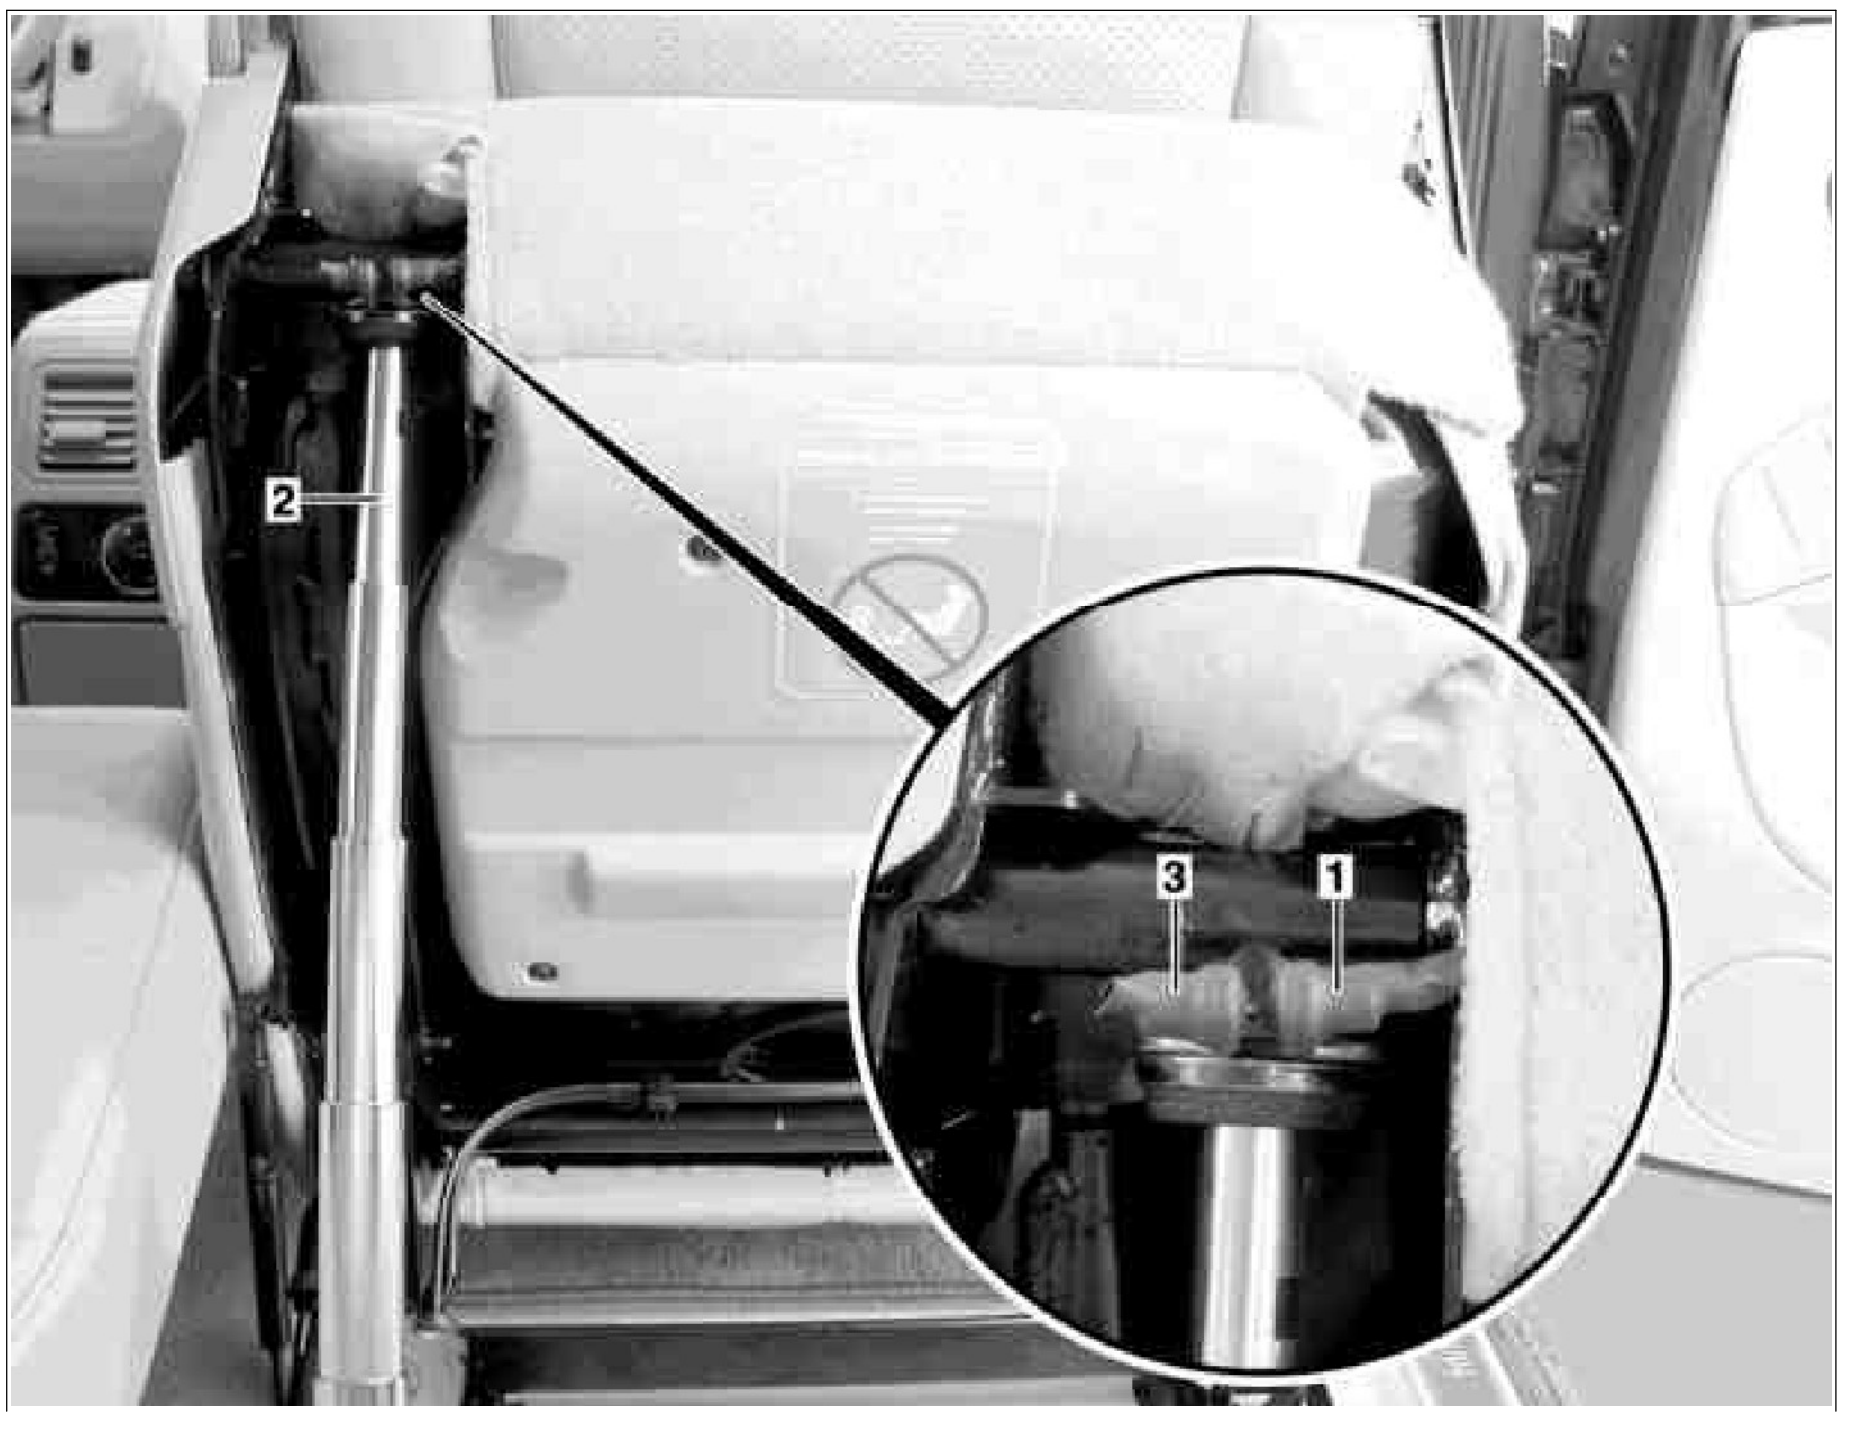
P91.12-2444-06

1 Shrink-on tubing
2 Telescoping strut
3 Shrink-on tubing

Damage Code	Cause	Remedy	
	Release cable disconnected from eyelets at top of telescoping strut.	1 Slide one piece of shrink-on tubing (1), approximately 25 mm long, onto release cable.	
		2 Reattach right end of release cable to eyelet at top of telescoping strut (2).	
		3 Position shrink-on tubing (1) over right cable connection to eyelet.	
		4 Reattach left end of release cable to eyelet at top of telescoping strut (2).	
		5 Position a second piece of shrink-on tubing (3), approximately 25 mm long, over left cable connection eyelet.	
		6 Carefully heat tubing until they shrink securely over release cable ends and eyelets of telescoping strut. Do not damage seat cover. Hot air gun	*WE58.40-Z-1007-03A
		7 Verify proper function of easy-entry seat.
